# Right Bundle Branch Block Morphology of the Paced QRS Complex and Diaphragmatic Capture During Temporary Transvenous Pacing: Where is the Pacing Catheter?

Alex Harrison, MD and Subramaniam Krishnan, MD  
Department of Medicine, Division of Cardiology, University of California Irvine  
Orange, California

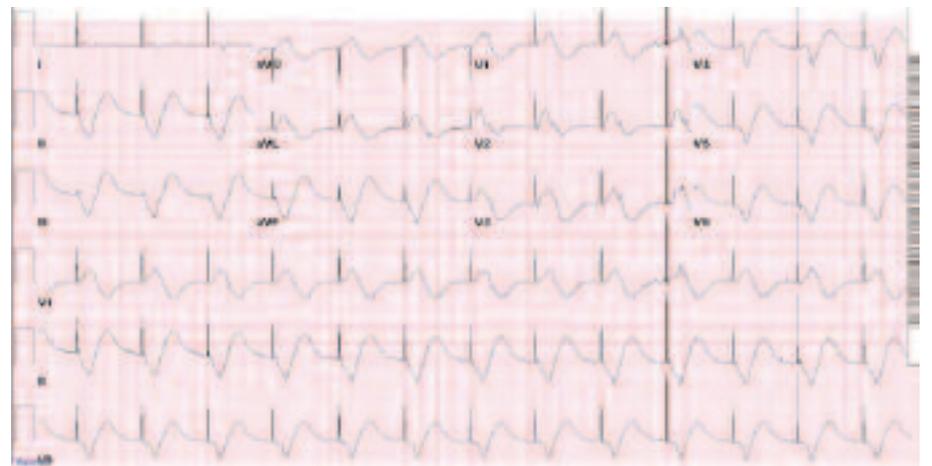
**Figure 1. Post temporary transvenous pacemaker insertion ECG showing a ventricularly paced rhythm at 80 beats per minute with RBBB pacing morphology.**

A post-procedure 12-lead electrocardiogram (ECG) showed successful ventricular pacing but with a RBBB morphology of the paced QRS complex (Figure 1). A post-procedure chest x-ray did not readily identify the location of the pacing wire because the lung fields were obscured due to pulmonary edema and morbid obesity (Figure 2). The location of the pacing wire was later determined to be in left pericardiophrenic vein due to the combination of RBBB paced QRS morphology and diaphragmatic stimulation caused by the pacing of the left pericardiophrenic nerve. When the patient went for permanent pacemaker insertion, fluoroscopy confirmed the location of the temporary wire in the left pericardiophrenic vein pacing the lateral epicardial surface of the left ventricle as well as the left hemi-diaphragm (Figure 3).

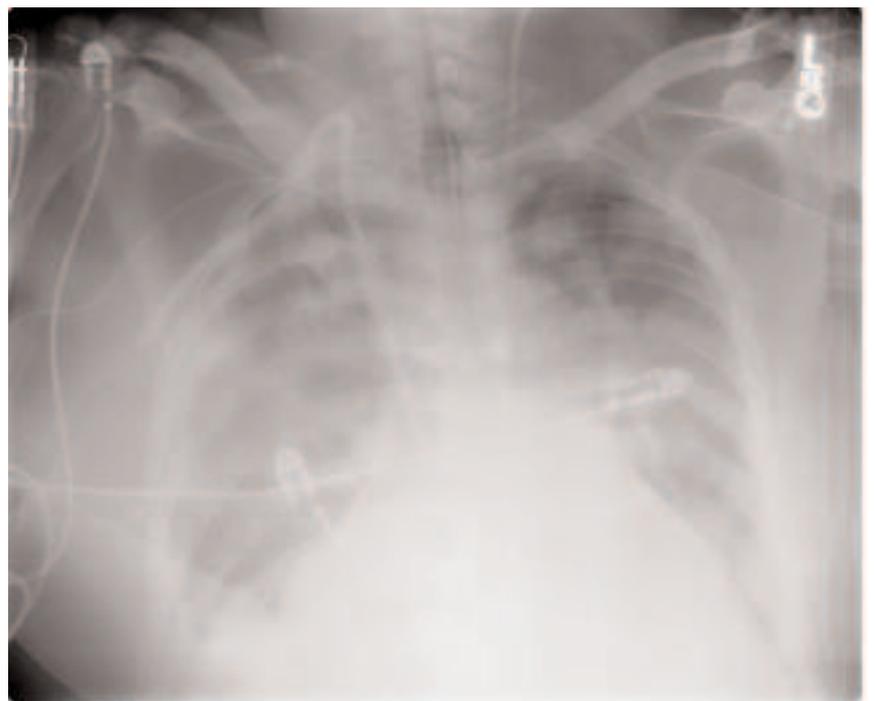
**Figure 2. Post temporary transvenous pacemaker insertion chest x-ray showing cardiomegally, congestive heart failure, satisfactory position of the endotracheal tube, tunneled left subclavian hemodialysis catheter, and left internal jugular pacing catheter with an obscured distal tip.**
