# Right Bundle Branch Block Morphology of the Paced QRS Complex and Diaphragmatic Capture During Temporary Transvenous Pacing: Where is the Pacing Catheter?

Alex Harrison, MD and Subramaniam Krishnan, MD  
Department of Medicine, Division of Cardiology, University of California Irvine  
Orange, California

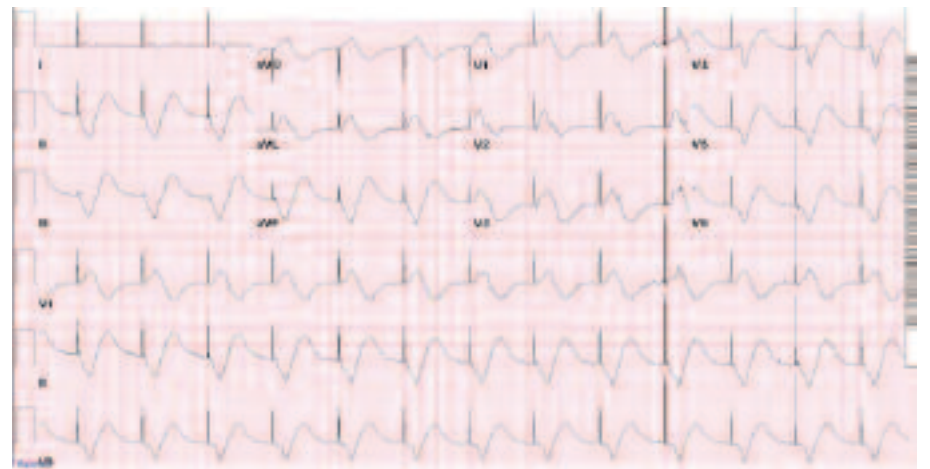
**Figure 1. Post temporary transvenous pacemaker insertion ECG showing a ventricularly paced rhythm at 80 beats per minute with RBBB pacing morphology.**

A post-procedure 12-lead electrocardiogram (ECG) showed successful ventricular pacing but with a RBBB morphology of the paced QRS complex (Figure 1). A post-procedure chest x-ray did not readily identify the location of the pacing wire because the lung fields were obscured due to pulmonary edema and morbid obesity (Figure 2). The location of the pacing wire was later determined to be in left pericardiophrenic vein due to the combination of RBBB paced QRS morphology and diaphragmatic stimulation caused by the pacing of the left pericardiophrenic nerve. When the patient went for permanent pacemaker insertion, fluoroscopy confirmed the location of the temporary wire in the left pericardiophrenic vein pacing the lateral epicardial surface of the left ventricle as well as the left hemi-diaphragm (Figure 3).

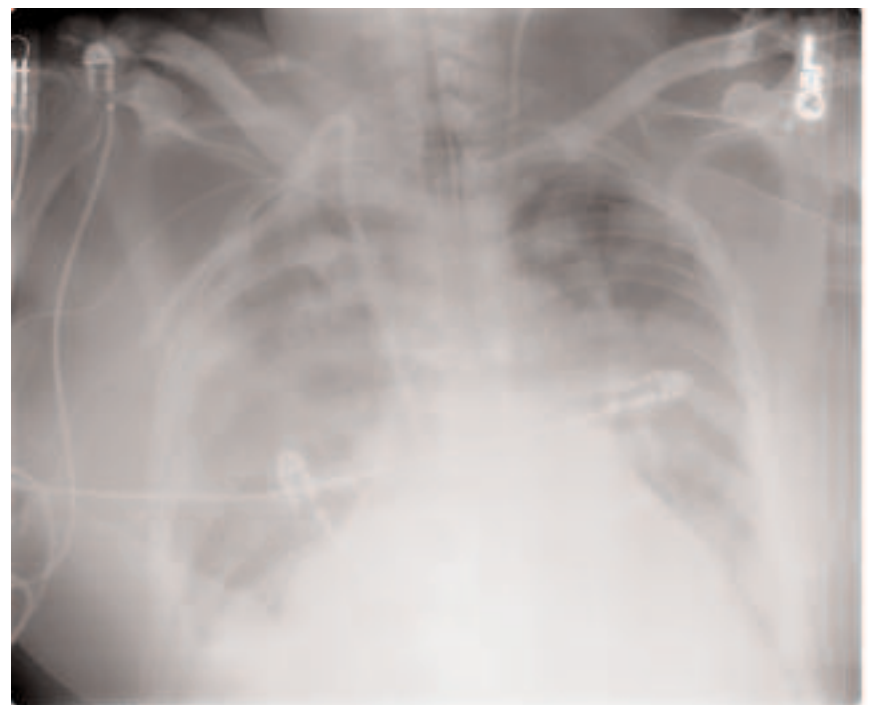
**Figure 2. Post temporary transvenous pacemaker insertion chest x-ray showing cardiomegally, congestive heart failure, satisfactory position of the endotracheal tube, tunneled left subclavian hemodialysis catheter, and left internal jugular pacing catheter with an obscured distal tip.**

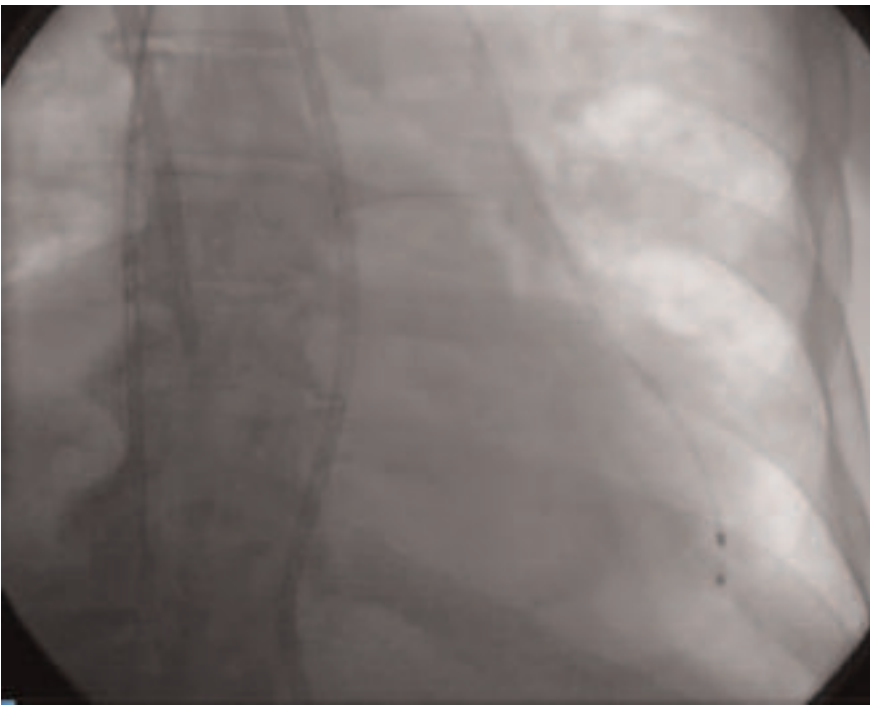
**Figure 3. Fluoroscopic image of the temporary transvenous pacing catheter positioned in the left pericardiophrenic vein along the lateral aspect of the left ventricle.**

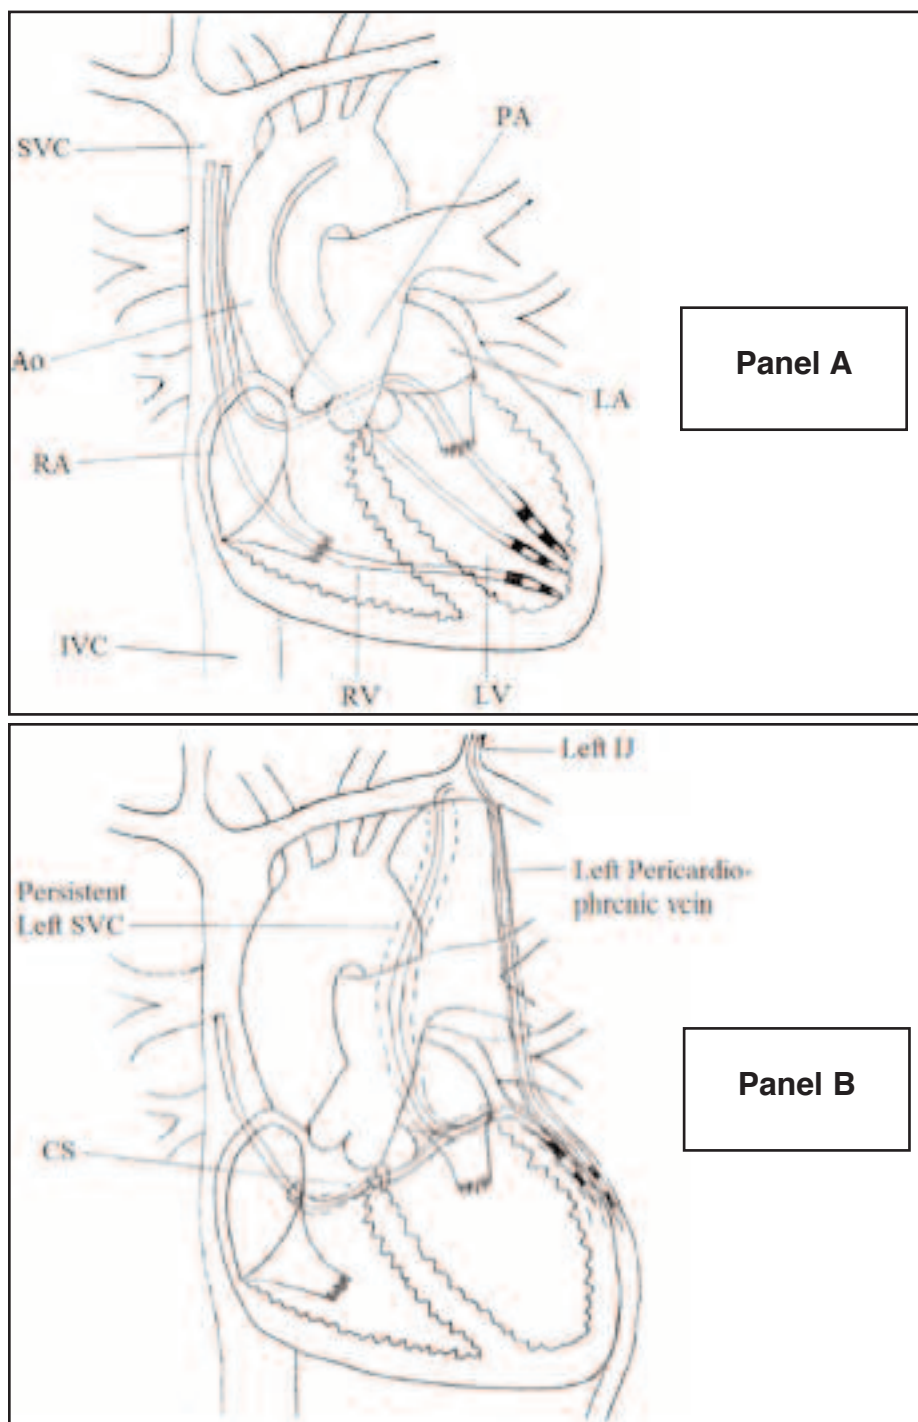
**Figure 4. Schematic drawings of potential vascular catheter courses to reach the left ventricular endocardium (Panel A) and the coronary venous system (Panel B). SVC = superior vena cava, Ao = aorta, RA = right atrium, IVC = inferior vena cava, RV = right ventricle, LV = left ventricle, PA = pulmonary artery, LA = left atrium, CS = coronary sinus, IJ = internal jugular vein.**

1. The catheter is in the right ventricle, but its position is in the posterior most portion of the right ventricle, far from the chest wall and precordial ECG leads V1-3, and results in a RBBB-paced QRS morphology.
2. The catheter is in the left ventricular endocardial cavity. This can occur via a variety of mechanisms (Figure 4, Panel A):
  - a. Intra-arterial rather than venous placement.
  - b. Passing the catheter through an inter-atrial communication — such as an atrial septal defect (ASD) or patent foramen ovale (PFO) — between the right and left atrium, and then through the mitral valve to the left ventricle.

3. The catheter enters the coronary venous system and is pacing the epicardial surface of the left ventricle. This also can occur via a variety of mechanisms (Figure 4, Panel B):

- a. The catheter inadvertently enters the coronary sinus from the right atrium and is advanced over the left ventricular surface through the tributary coronary sinus veins.

- b. The catheter is advanced via a persistent left superior vena cava, enters into the coronary sinus, and is advanced over the left ventricular surface through the tributary coronary sinus veins.

- c. The catheter enters the pericardiophrenic vein from the left brachiocephalic vein and is pacing the lateral left ventricular epicardial surface from the pericardiophrenic bundle overlying the heart, but is not actually in contact with the myocardium.
